Engineering Assessment of Big House at Summit Station, Greenland

Final Report

Lynette A. Barna, Keran J. Claffey, James S. Buska,
and Jennifer L. Mercer

April 2011

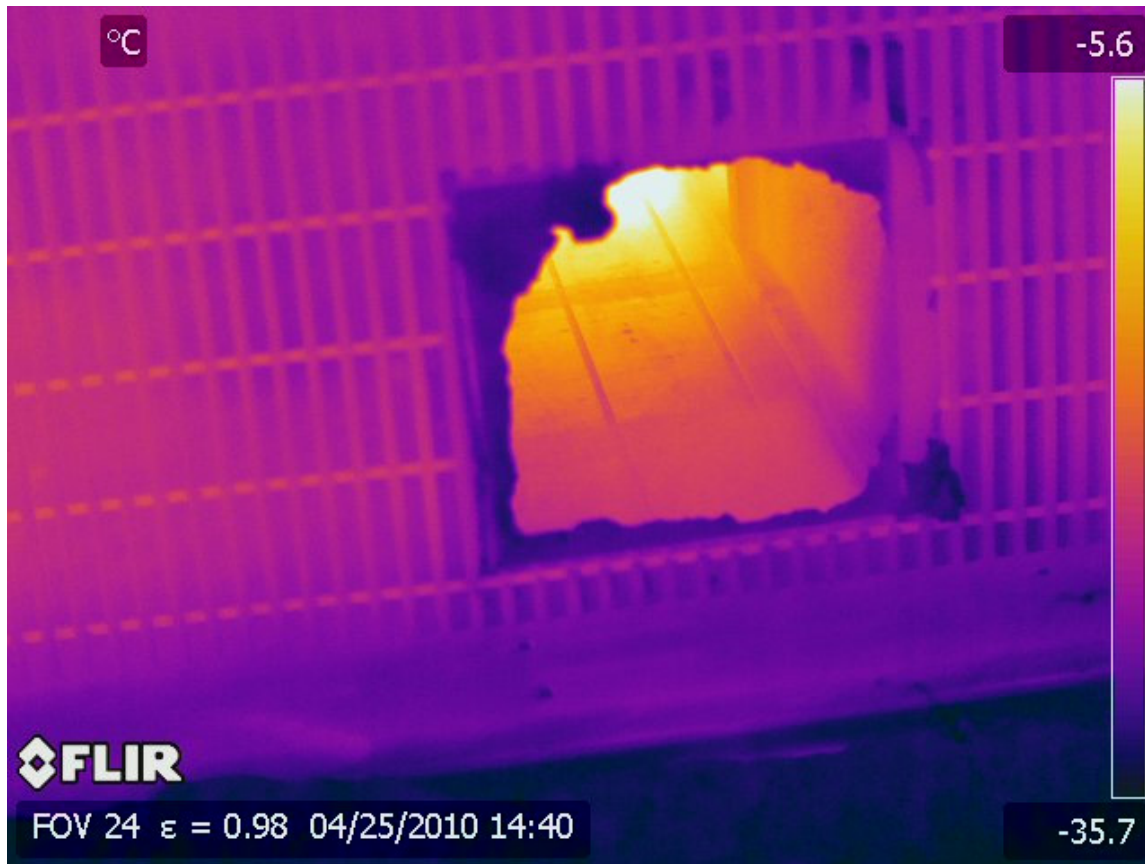
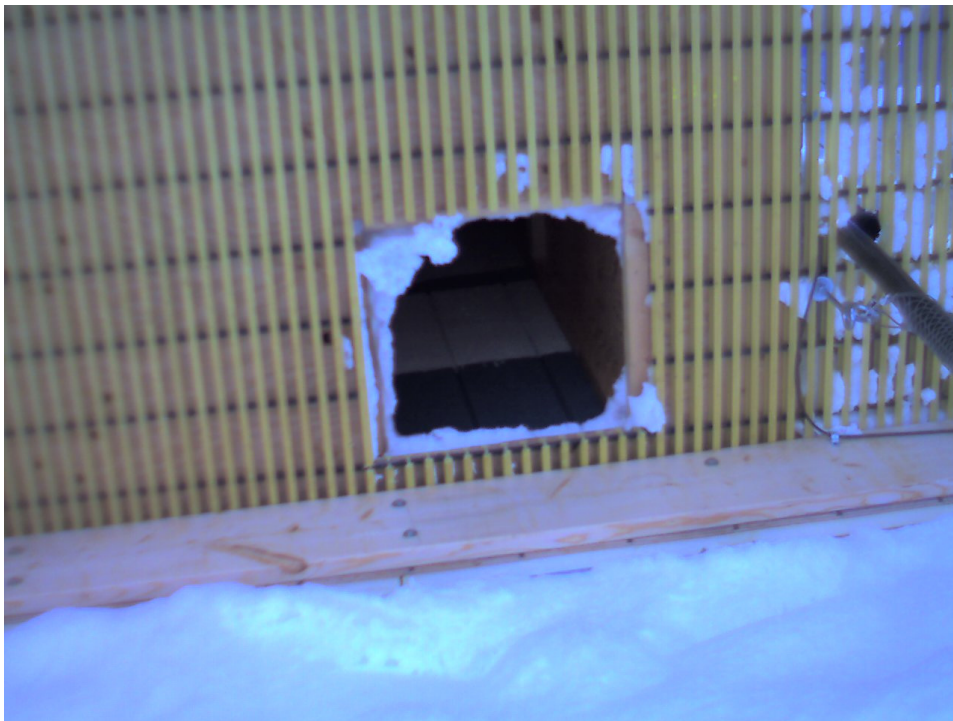
Lastly, Figures 31 and 32 show IR and visual images of the sewer outfall pipe and the opening of the fresh air intake vent in the kitchen, respectively. The sewer outfall pipe shows some heat loss at the interface between the housing around the pipe and the base of the building. Likewise, there is heat loss from the kitchen through the air intake vent.

Figure 32. Base of the building, IR and visual images of the kitchen air intake vent.

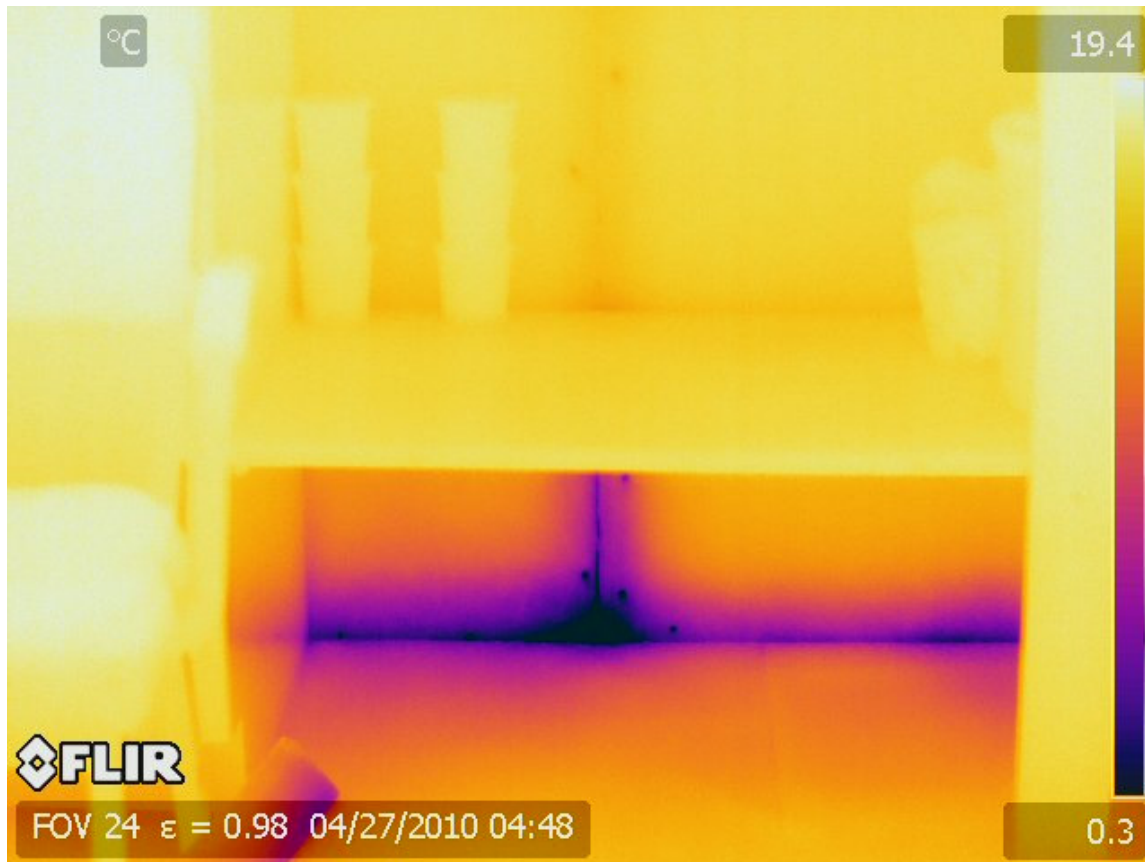
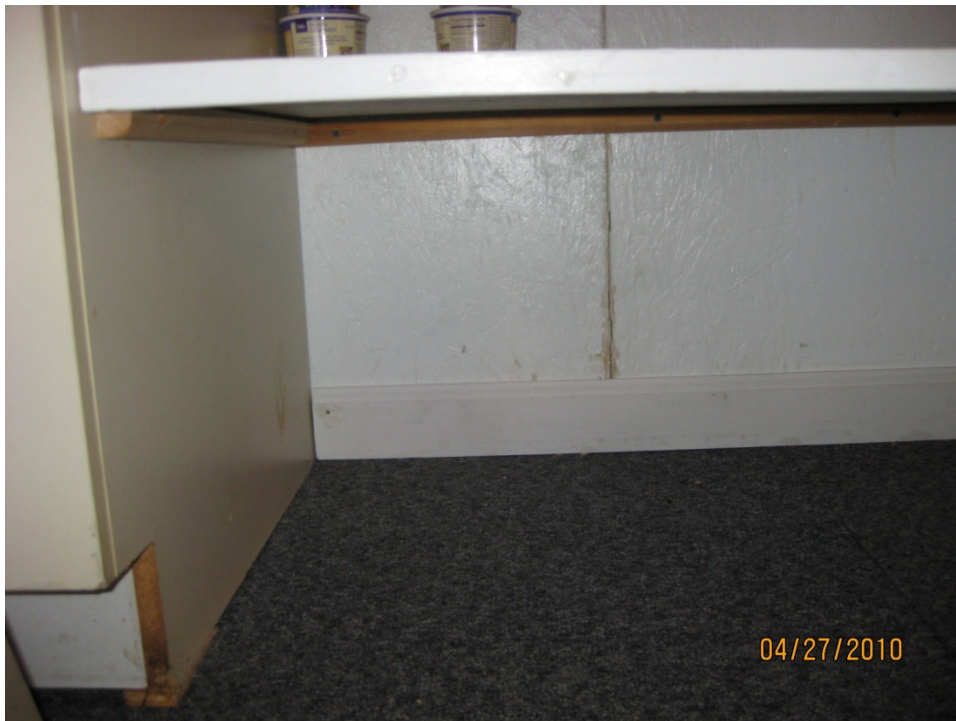
Figure 36. IR and visual images of the cold location under the counter in the main room before it was sealed.

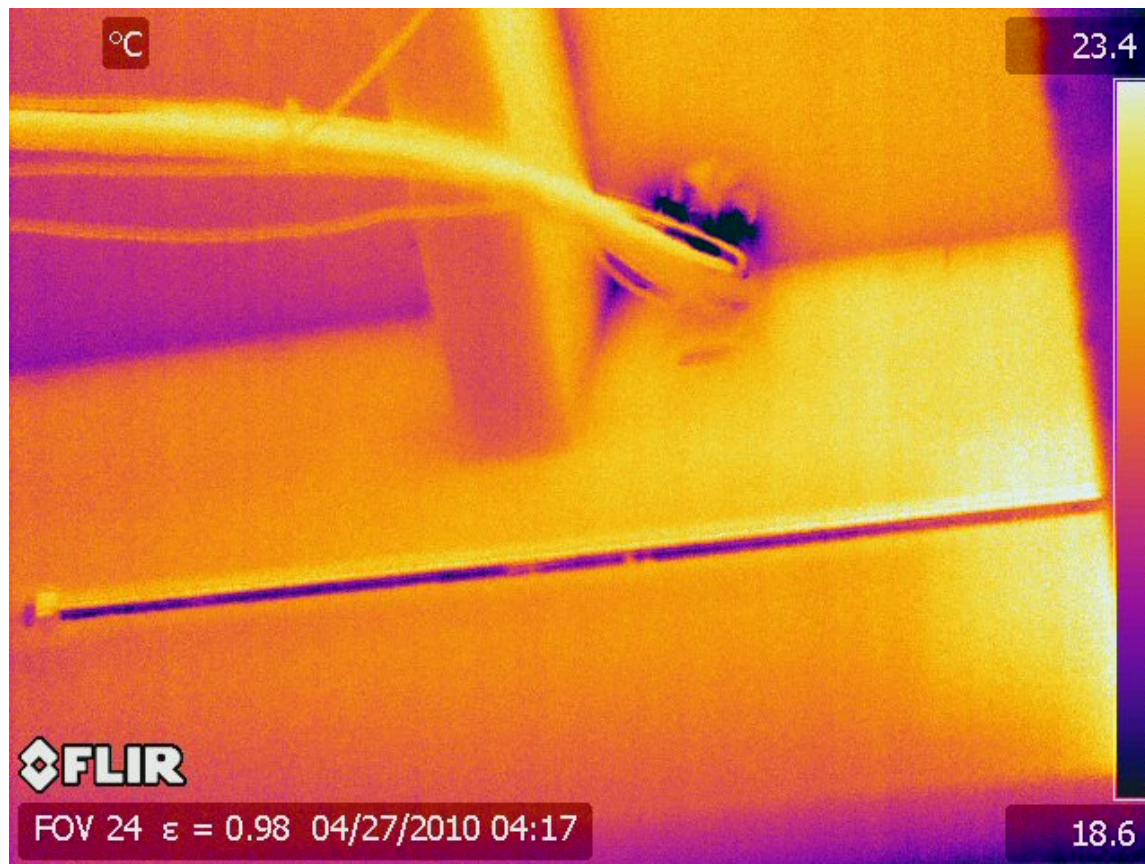
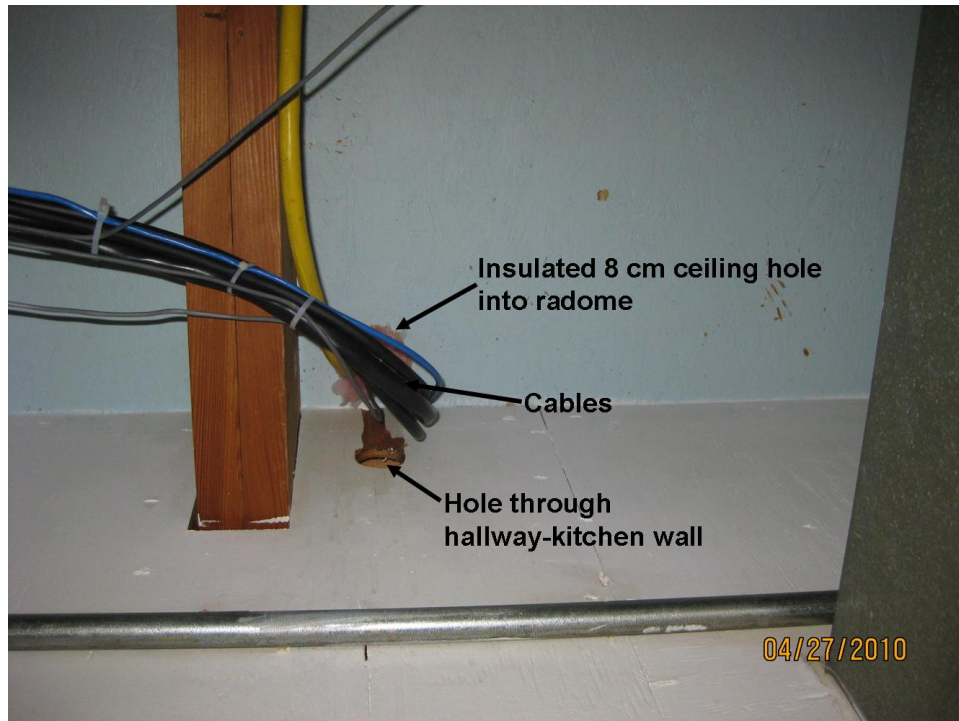
The radome on the roof was not observed to be a significant contribution to heat loss. However, there is some heat loss from the inside of the Big House where the cables run through the ceiling up into the radome.

Figure 38. IR and visual images of the ceiling in the hallway where cables pass through into the radome.

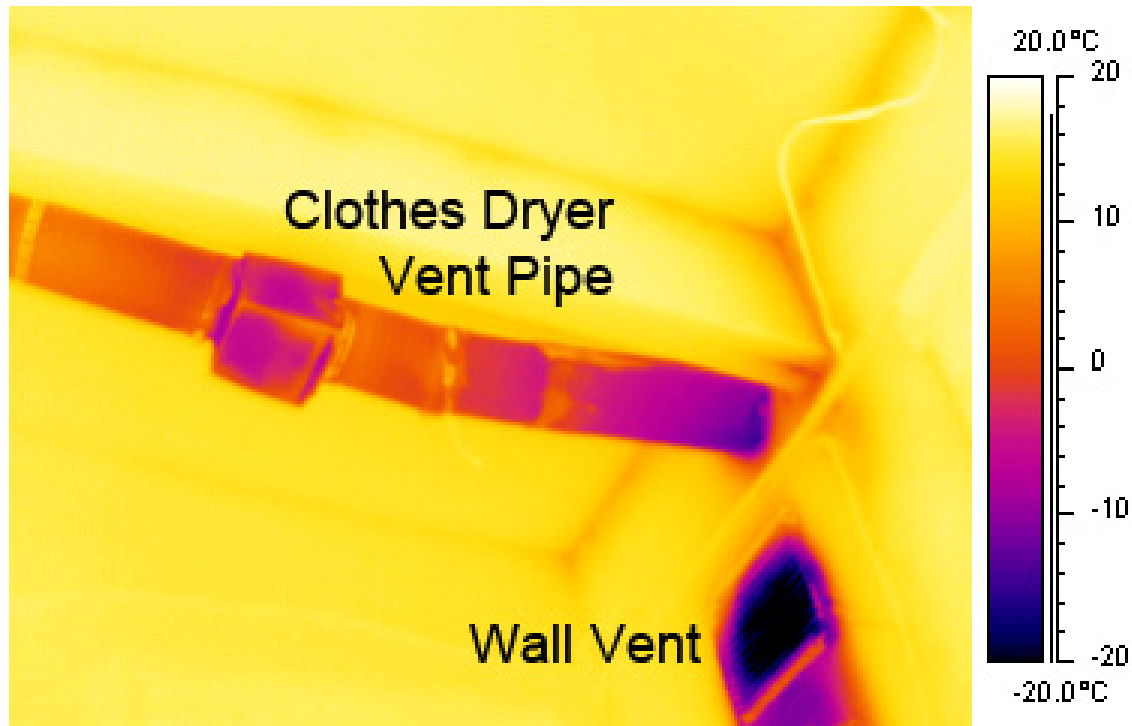
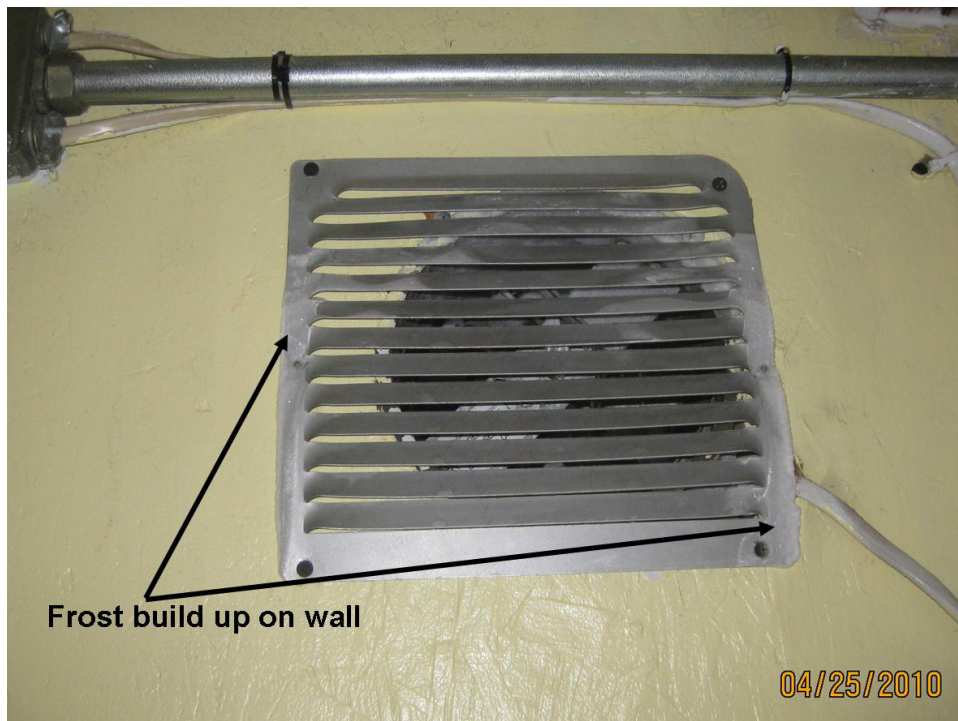
At the time of the IR survey, an air vent centrally located on the north wall in the laundry room was a direct pathway for cold air to infiltrate into the building. This through-the-wall vent is no longer an issue as it was removed later during the 2010 summer season. The hole was insulated and sealed (CPS 2010). Another possible solution would be to relocate this vent to an internal location, such as the wall between the laundry room and scullery, or the wall between the laundry room and hallway. Moving this warm, moist air within the Big House would serve to disperse the humidity where it is needed into the main room. This would also alleviate the ice buildup on the north exterior wall.

Figure 41. IR image of both the clothes dryer and through-wall vent in the laundry room/bathroom. The visual image is a closeup of the through-wall vent noting frost buildup from cold air infiltration.

- Repair the vent in the laundry room to operate effectively, possibly through the use of an automated system, in removing warm moist air from the clothes dryer from inside. Yet, when it is not in operation, it is securely closed with cold climate dampers.

- Use durable exterior hardware should to ensure a proper seal. A direct vent in the north wall of the laundry room created a pathway for cold air infiltration. This vent was removed and the hole insulated and sealed during the 2010 summer season. For through-wall vents, durable exterior hardware should be used to ensure a proper seal when the vent is not in use. Another possible solution would be to relocate this vent to an internal location, such as the wall between the laundry room and scullery, or the wall between the laundry room and hallway. Either of these locations would serve to move this warm, moist air within the Big House to disperse the humidity where it is needed into the main room, and this would also alleviate the ice buildup on the north exterior wall.

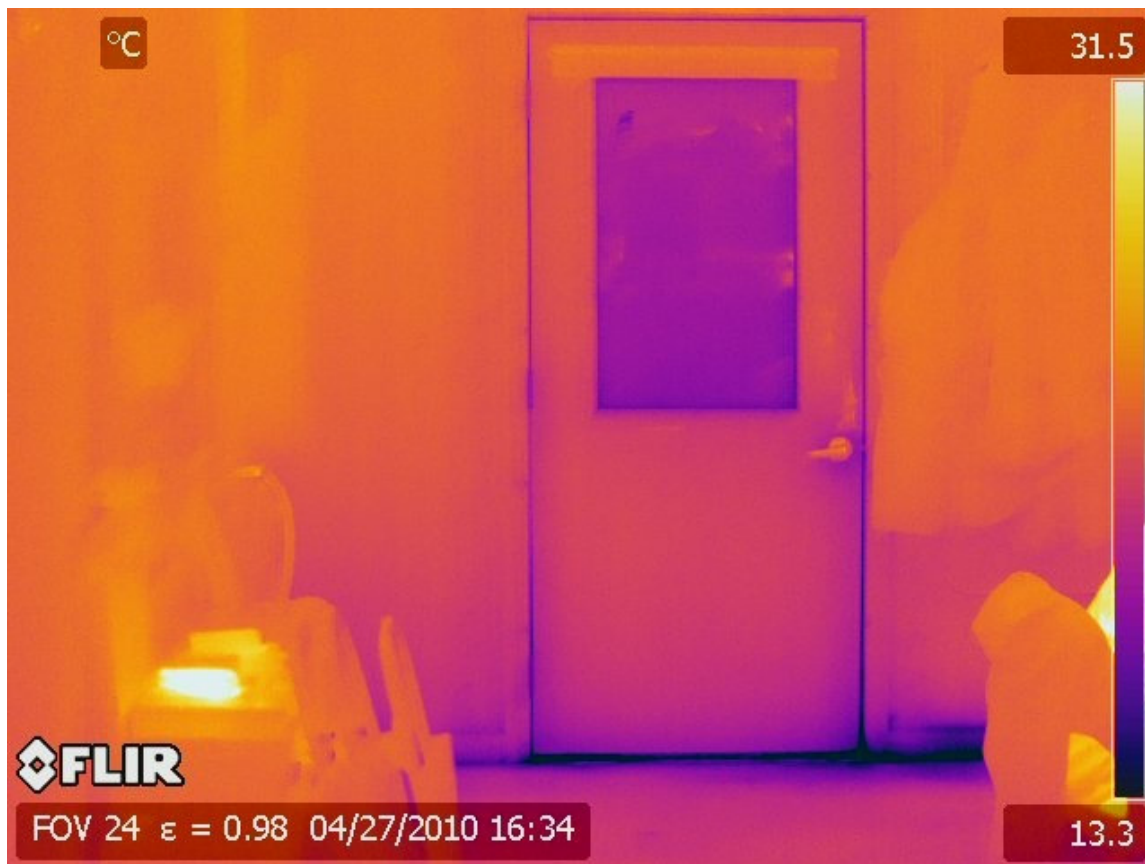
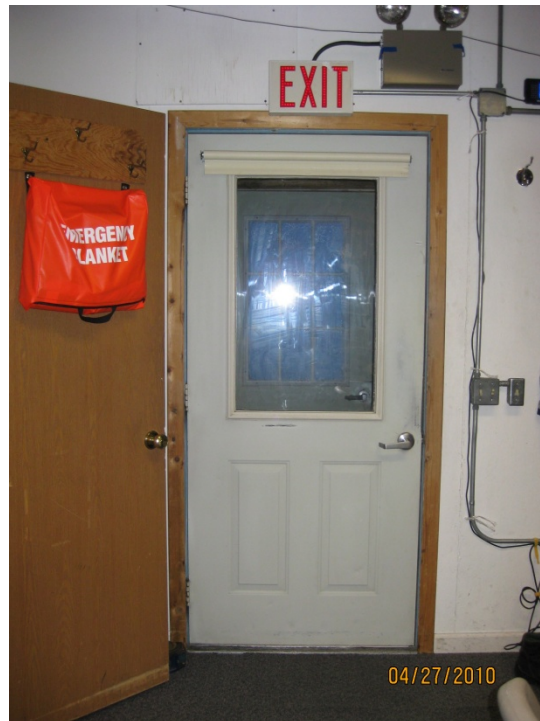
The IR imagery shows heat loss around both the east and west vestibule exterior doors, likely from wear on the door seal, as well as through the window. Both of these doors are insulated residential doors with a viewing window in the upper half of the door.

Figure 42. IR and visual images of the main entrance door in the east vestibule.

- Reduce heat loss around the exterior doors in both the east and west vestibules by replacing the seals.
- Remove the windows in the east vestibule if they are not necessary. This will reduce moisture buildup. Another method to reduce the amount of moisture buildup in arctic entryways is to maintain a constant low temperature (between 2 and 5°C) to mitigate the large temperature swings in an unheated vestibule.

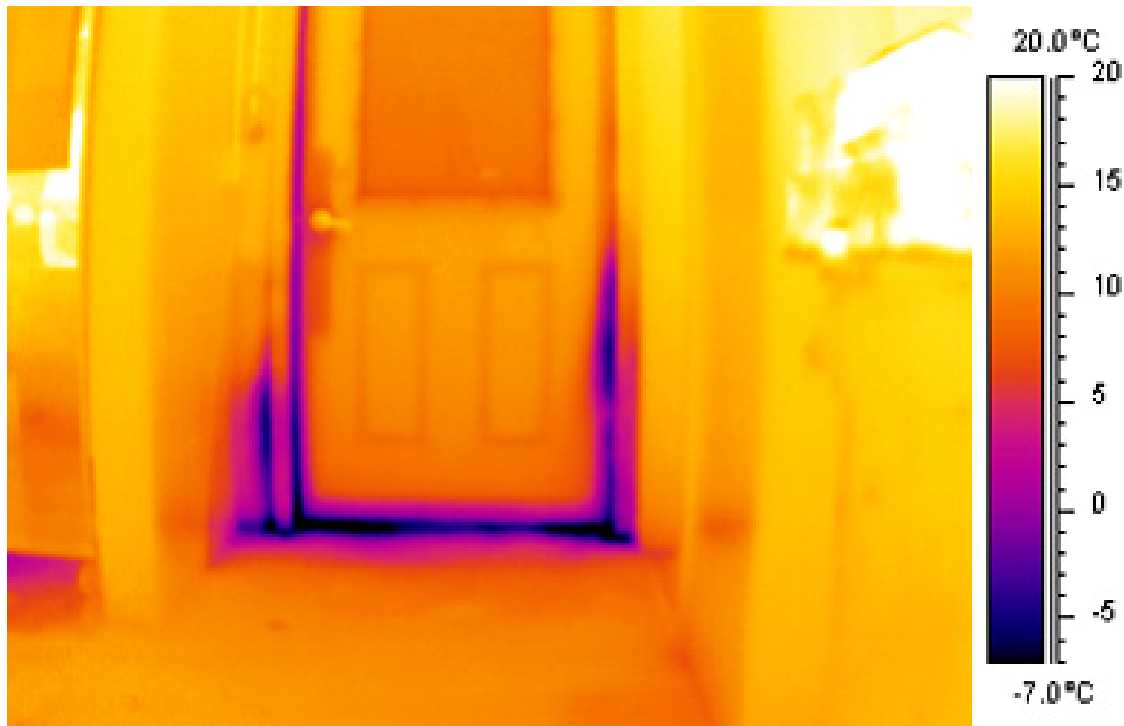
Figure 43. IR and visual images of the main entrance door in the west vestibule.
